Page 1
JSC SPORTINE AVIACIJA Bulletin No. 012.5.Re.001A	Total 1

Bulletin No. 012.5.Re.001A

SERVICE OF THE LAK-12 SAILPLANE AFTER 500 FLIGHT HOURS OR 5-YEAR OPERATION

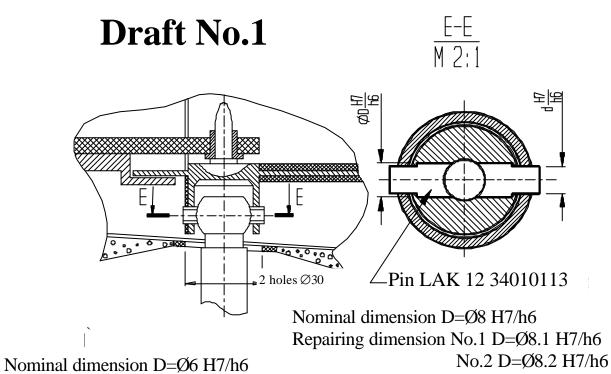
Elevator backlash is eliminated replacing pins LAK-12 34010113. After pins replacement "scissors" between rear edges of the elevator are permitted up to **D** 2mm (see drafts No.1, No.2)

No.2 D=Ø6.2 H7/h6

Repairing dimension No.1 D=Ø6.1 H7/h6

"Scissors" between elevators are eliminated using pin of special form (see draft No.2 version "scissors")

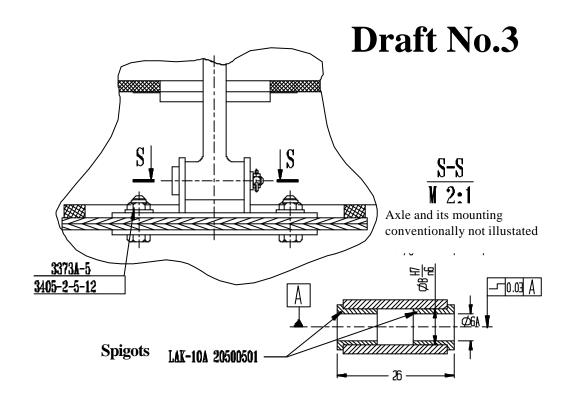
Draft No.4

Backlash in the aileron control attachment point is eliminated replacing spigots LAK-10A20500501 and fastening nuts 3373A-5 on the bracket of ailerons control attachment point.

Spigot LAK-10A20500501 1. Material

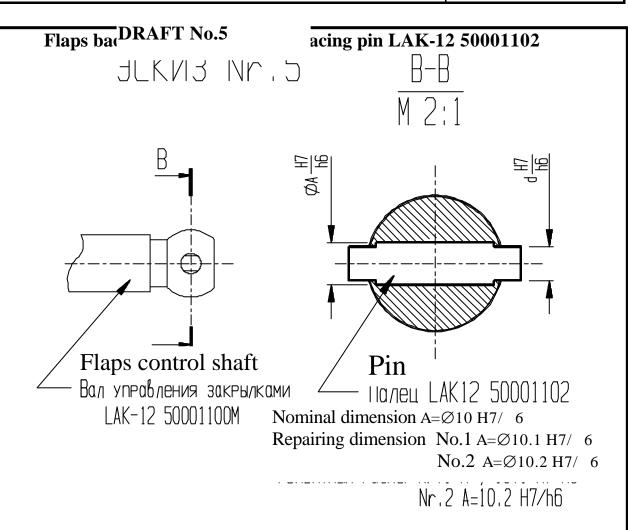
DRAFT No.6

c) Flaps backlash elimination:

1. Rounded rod

2. Thermal processing: $\mathbf{S}_b=120\pm10 \text{ kG/mm}^2$

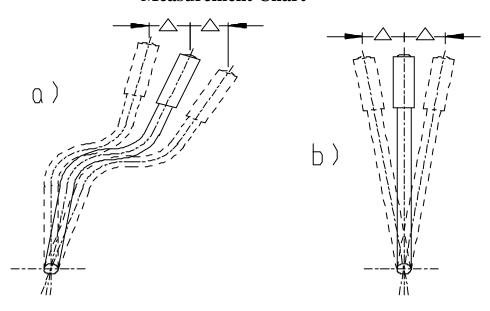
Measurement Chart

2. Measure the backlash of control stick.

Backlash of control stick is measured when the ailerons and elevators are fixed.

- a) when the elevator is fixed- **D**=±1.5mm.
- b) when the ailerons are fixed- **D**=±1.5mm.

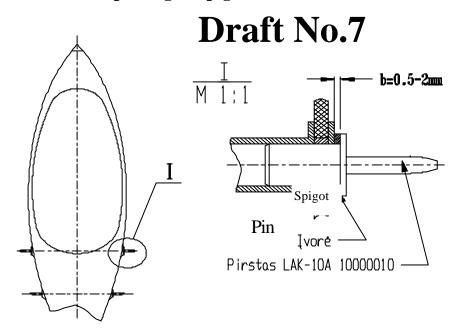
Draft No.8

3. Measure a backlash between fuselage and wing cantilevers: Backlash is measured in the attachment point of fuselage and wing cantilevers.

Backlash tolerance- **D**=0.5mm Backlash is eliminated putting in spigots (see draft No.8)

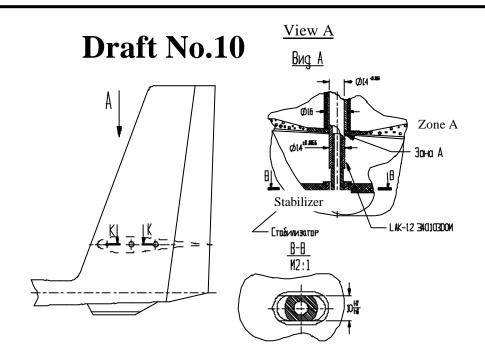
4. Measure the transverse backlash of the stabilizer in respect to the fuselage. Backlash tolerance **D**=4mm.

Areas of corrosion in zone A are not tolerable. If corrosion is found replace the tube LAK-12 34010300M

Stabilizer backlash is eliminated covering the stabilizer tube surface A with additional chrome layer (see draft No.11)

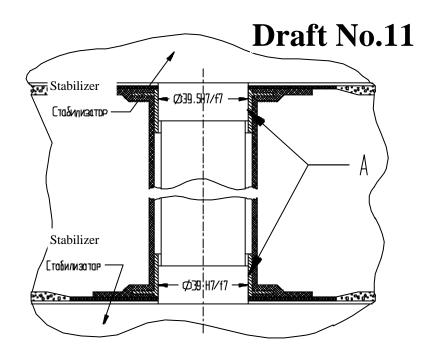
ATTENTION: After pin removement check the hole internal surface A. If the areas of corrosion found, grind the surface and prime.

Fuselage lateral pin is removed by gentle blows of a little load against the support plate (see draft No.9)
