JSC "SPORTINĖ AVIACIJA"	Page 1
Service Bulletin No. 012.5. Re.002A	Pages 33

Service Bulletin No. 012.5.Re.002A

**SERVICE WORKS FOR THE GLIDER LAK-12
AFTER 15 YEARS OF OPERATION**

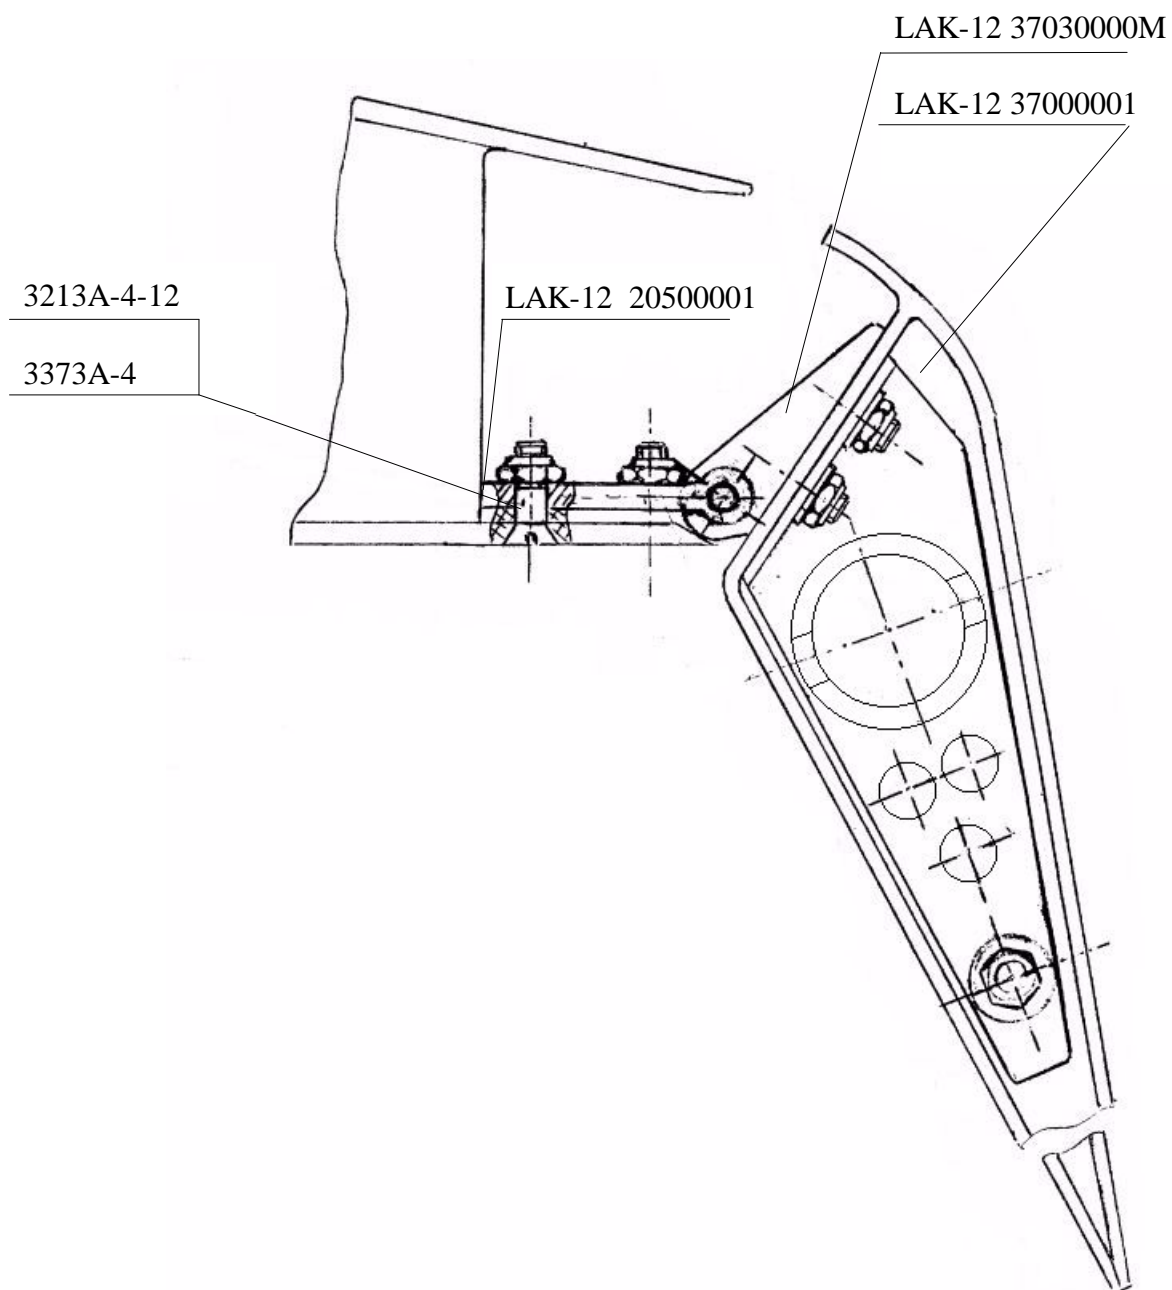
Sketch No.1

2. Inspect the flap hinges located on the flap. The flaps hinges are inspected as follows:
 - a) disconnect and remove wings from fuselage;
 - b) place the wings on the supports so, that it is possible to deflect flap down as much as possible (see sketch No.1);

6. Inspect flap hinges LAK-12 20 50 00 01 which are at the root of the wing (see. sketch Nr.1):

- a) with the magnifying lens x4 inspect the hinges LAK-12 20 50 00 01, if corrosion areas are found, it is necessary to remove corrosion with sand paper grid 120, paint with primer F-809, after primer has dried - paint with paint 7001 Urki-Nox;
- b) flap hinges having cracks must be replaced with new ones LAK-12 20 50 00 01;
- c) hinges LAK-12 20 50 00 01 are mounted to the structure by bolts 3213A-4-12, nuts 3374A-4 (see sketch No.1).

10. Inspect the root rib of the flap LAK-12 37 00 00 01 (see sketch No.1):

- a) in a case if flap root rib de-lamination from the flap skin is found, repair as described in the “Sailplane LAK-12 Maintenance Manual”;
- b) paint damaged areas of the flap root rib made of plywood LAK-12 37 00 00 01. Paint as described in the instruction VIAM Nr.891-66;
- c) with the magnifying lens x 4 inspect the flap controls connection coupling LAK-12 37 05 00 00 M and the surface of the rib LAK-12 37 00 00 01;
- d) in a case if crack found, flap controls connection coupling LAK-12 37 05 00 00 M and root rib of the flap LAK-12 37 00 00 01 must be replaced with the new ones.

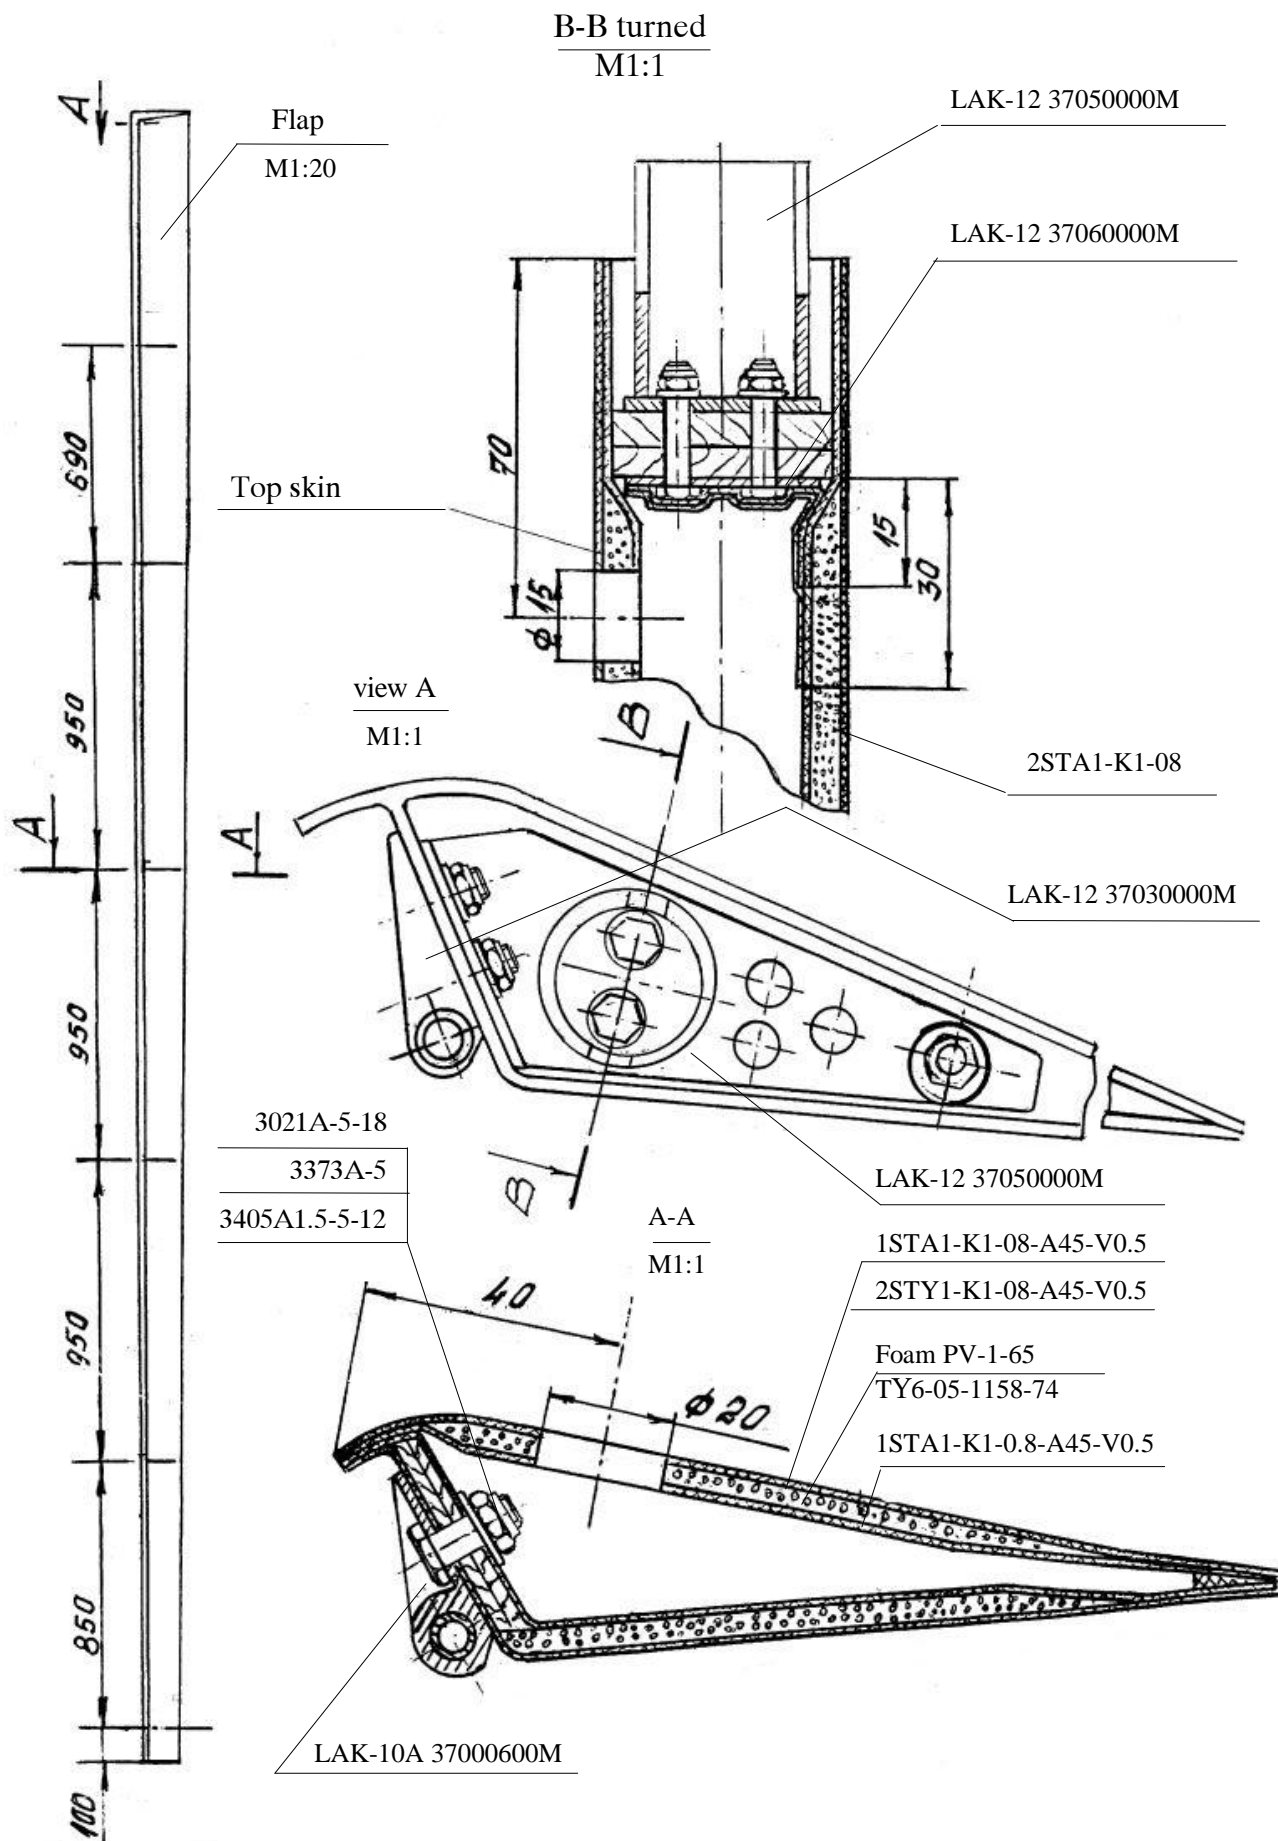
Sketch No. 2

- c) using magnifying lens x 4 visually inspect external surface of the flap hinges for cracks;
 - d) in a case if cracks are found on a surface of hinge, the opening of $\varnothing 20$ mm diameter has to be made (see sketch No.2 section A-A). Remove hinge bracket LAK-10A 37 00 06 00 M;

- e) the hinge bracket LAK-12 37 03 00 00 M is removed by unscrewing mounting bolts, which connect hinge bracket with flap controls coupling LAK-12 37 05 00 00 M (see sketch No.2 view A);

- f) the hinge brackets having cracks must be replaced with the new ones LAK-10A 37 00 06 00 M, LAK-12 37 03 00 00 M;
 - g) the hinge brackets LAK-10A 37 00 06 00 M are attached to the structure by bolts 3021A-5-18, nuts 3373A-5 and washers 3405A1.5-5-12;

- a) the opening of $\varnothing 15$ mm diameter in the top skin of the flap has to be made (see sketch No.2 section B-B);
 - b) using inspection light, inspect the surface of the plate LAK-12 37 06 00 00 M;

- c) in a case if corrosion damaged surface is found, corrosion has to be removed with sand paper grid 120;
 - d) paint sanded area with the primer F-809 and gray paint 7001 Urki-Nox.

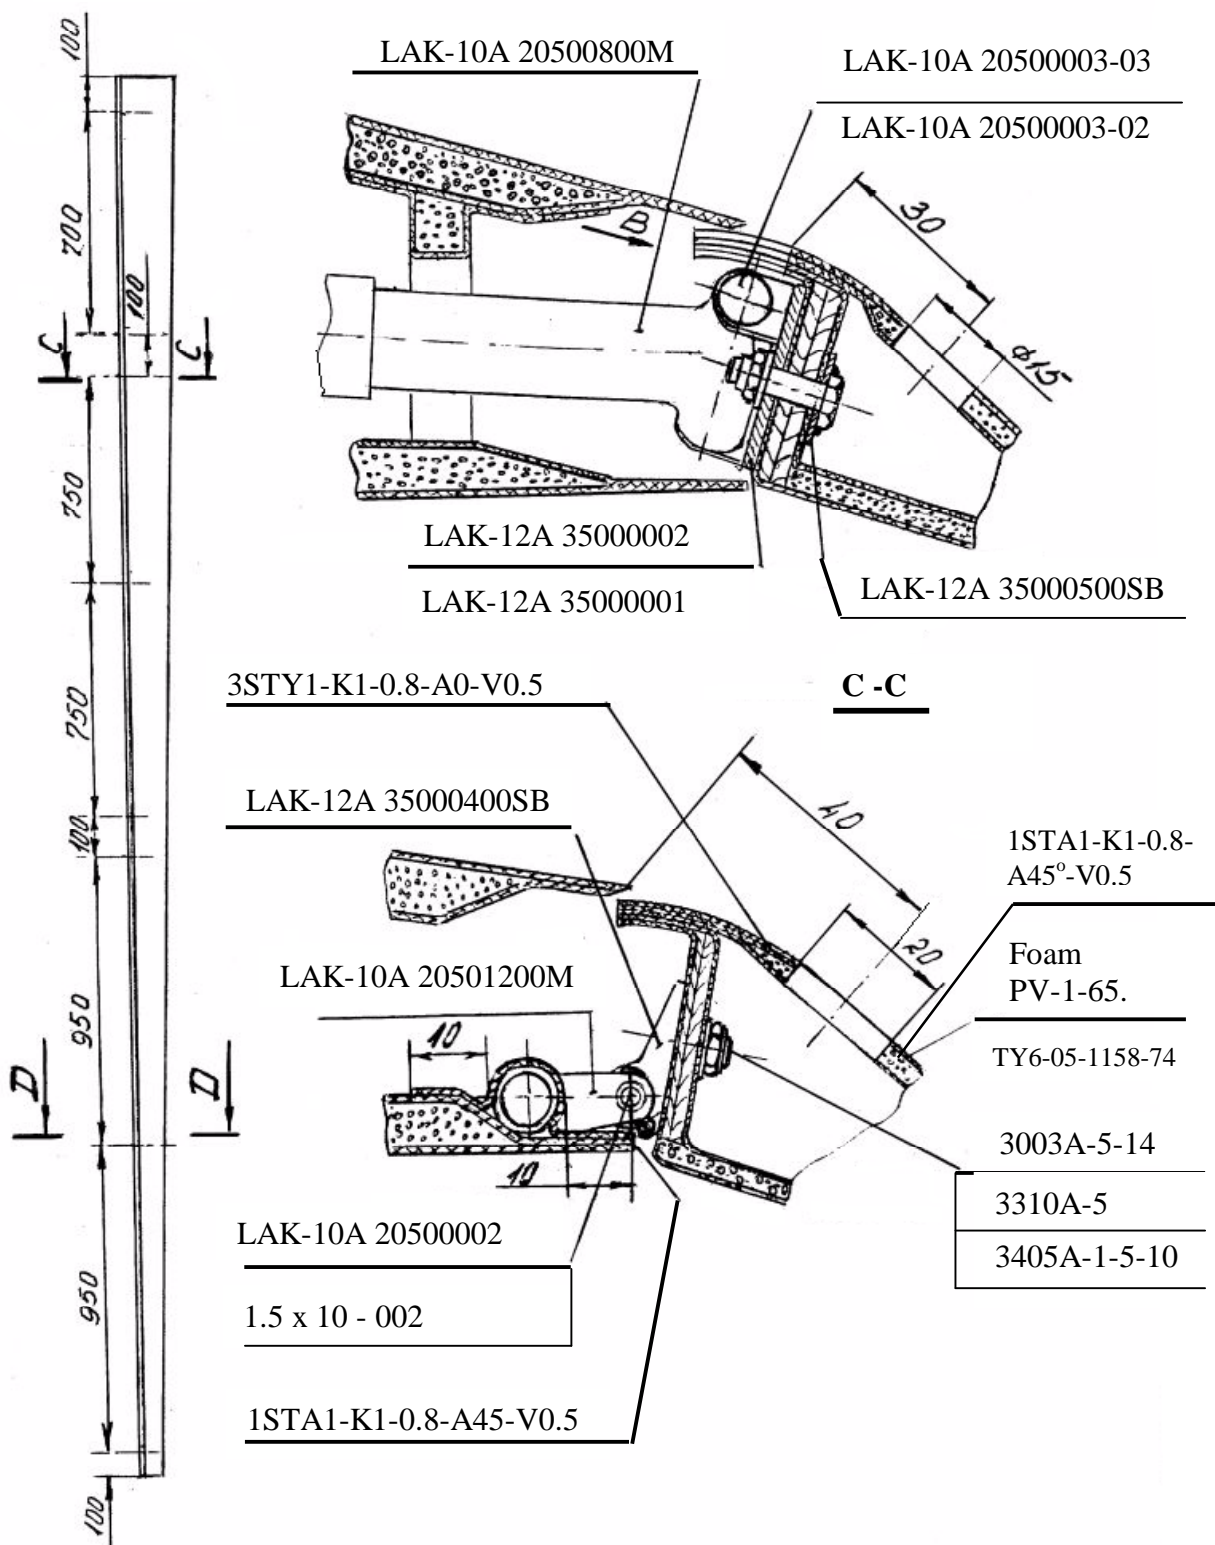
Sketch No.3

4. Inspect the aileron hinges located on the aileron. The aileron hinges are inspected as follows:
 - a) deflect the aileron down and remove the shafts LAK-10A 20 50 00 03-02, LAK-10A 20 50 00 03-03 from both aileron control units (see sketch No.3);

- b) remove the aileron by first removing cotter pins 1.5x10-002 and pulling out pins LAK-10A 20 50 00 02 (see sketch No.3 section C-C);
 - c) using magnifying lens x 4 visually inspect aileron hinge brackets LAK-12A 35 00 04 00 SB. Inspect for the cracks on external surface of the hinge bracket.

- d) In a case if crack is found on the aileron hinge bracket LAK-12A 35 00 04 00 SB, make the opening of $\varnothing 20$ mm diameter (see sketch No.3 section C-C) in the tip skin of the aileron and remove hinge bracket LAK-12A 35 00 4 00 SB;
- e) hinge bracket LAK-12A 35 00 4 00 SB is removed by unscrewing mounting bolt 3003A-5-14 (see sketch No.3 section C-C);
- f) aileron hinge brackets having cracks must be replaced with the new ones LAK-12A 35 00 4 00 SB;
- g) hinge brackets LAK-12A 35 00 4 00 SB are attached to the structure by bolts 3003A-5-14, nuts 3310A-5 and washers 3405-1-5-10;
- h) the opening of $\varnothing 20$ mm diameter in the top skin should be repaired as described in the “Sailplane LAK-12 Maintenance Manual”.

- a) using magnifying lens x 4 visually inspect flap and aileron mounting hinges LAK-10A20 50 12 00 M (see sketch No.3 section C-C);
- b) in a case if corrosion damaged surface is found, it is necessary to remove corrosion with sand paper grid 120, paint with primer F-809, after primer has dried - paint with paint 7001 Urki-Nox;
- c) flap and aileron mounting hinges on a wing having cracks must be replaced by new ones LAK-10A 20 50 12 00 M;
- d) inspect lamination to the structure of the aileron and flap mounting hinges LAK-10A 20 50 12 00 M, in a case if de-lamination of plies is found, remove old plies and lay-up new plies of fabric (see sketch No.3 section C-C).

7. Inspect the surface of the mounting plates LAK-12A 35 00 05 00 SB of the aileron push-rod connection brackets LAK-12A 35 00 00 01, LAK-12A 35 00 00 02 (see sketch No.3):

- a) make the opening of $\varnothing 15$ mm diameter in the top skin of aileron, in a place where bracket is mounted (see sketch No.3);
- b) in a case if corrosion is found on a surface of the plate LAK-12A 35 00 05 00 SB, it is necessary to remove corrosion with sand paper grid 120, paint with primer F-809, after primer has dried - paint with paint 7001 Urki-Nox;

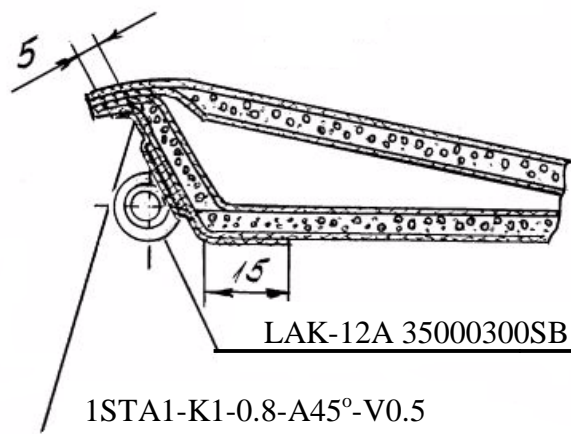
D-D
M1:1

8. Inspect lamination of the aileron aft hinge LAK-12A35 00 03 00 SB to the structure (see sketch No.3 section D-D), in a case if de-lamination of plies if found, remove old plies and lay-up new plies of fabric.

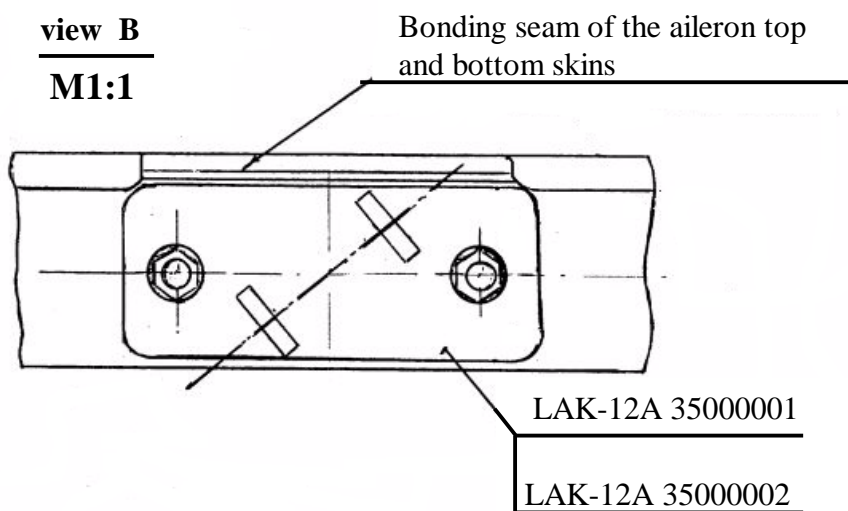
view B
M1:1

9. Inspect bonding seam of the top and bottom skins of the aileron (see sketch No.3 View B). In a case if de-lamination is found, repair bonding seam as described in the “Sailplane LAK-12 Maintenance Manual”.

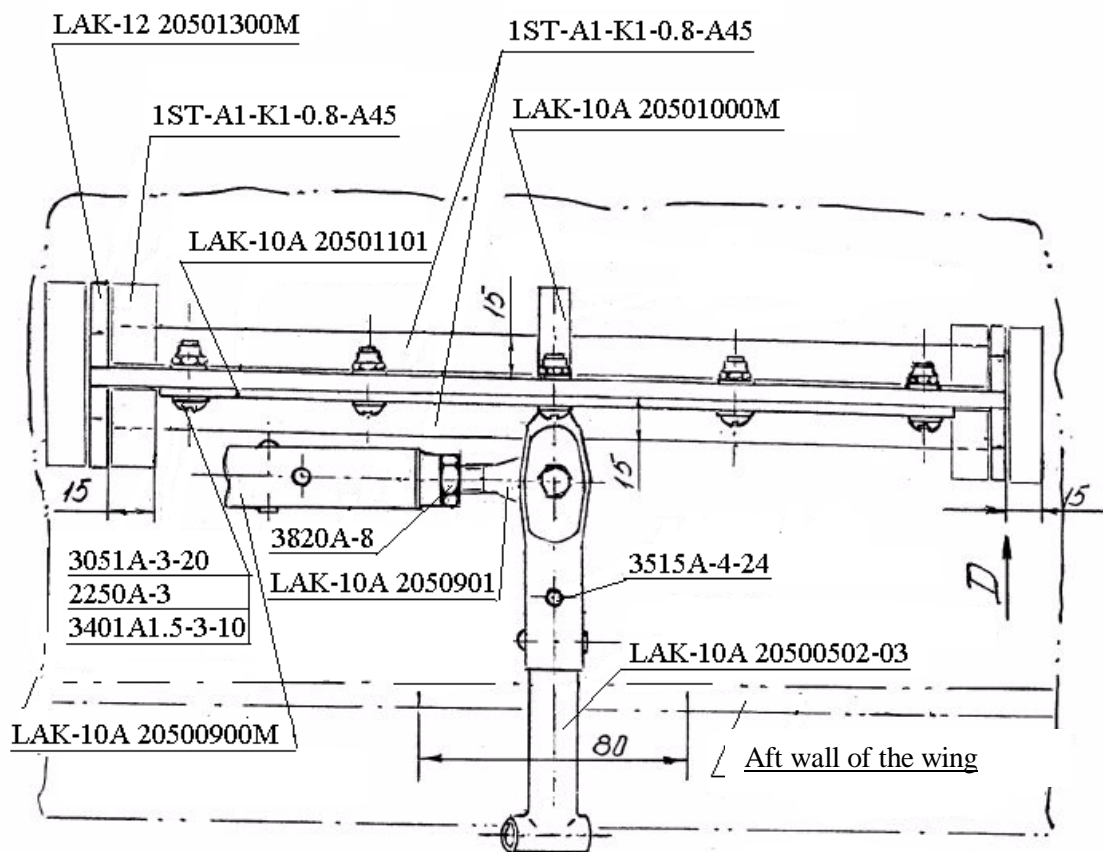
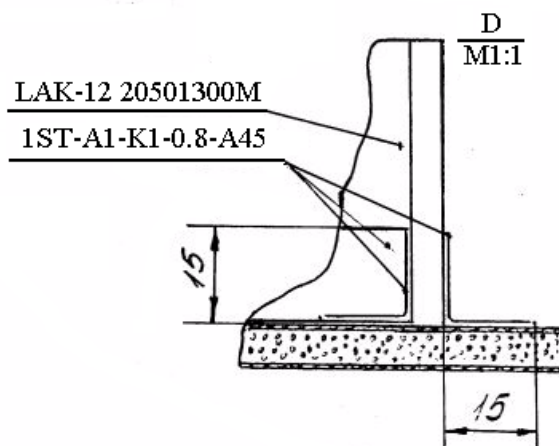
Sketch No.5

12. Inspect the outboard aileron control units (see sketch No.5):

- a) through the opening l=80 mm in the aft wall of the wing, with the help of flash light, inspect the aileron control unit push-rod LAK-10A 20 50 09 00 M adjustable rod end LAK-10A 20 50 09 01 lock nut 3820A-8 for tightness. If the nut is loose, tighten the nut 3820A-8 and paint with the primer F-809;

- b) inspect surfaces of the control guides LAK-12 20 50 13 00 M, if cracks are found, they must be replaced with the new guides LAK-12 20 50 13 00 M. In a case if local humidity damage to the plywood parts are found, plywood surfaces has to be painted according to requirements of the instruction VIAM Nr.891-66;

- c) inspect surface of the controls levers LAK-10A 20 50 10 00 M in the area of rivet heads 3515A-4-24 (see sketch No.5) connecting control levers with the parts LAK-10A 20 50 05 02-03. In a case if cracks are found, levers has to be replaced with the new ones LAK-10A 20 50 10 00 M;

- d) inspect the aileron control unit guide LAK-12 20 50 13 00 M bonding to the structure (see sketch No.5). If de-lamination of bonding plies is found, remove old plies and make the new lamination;

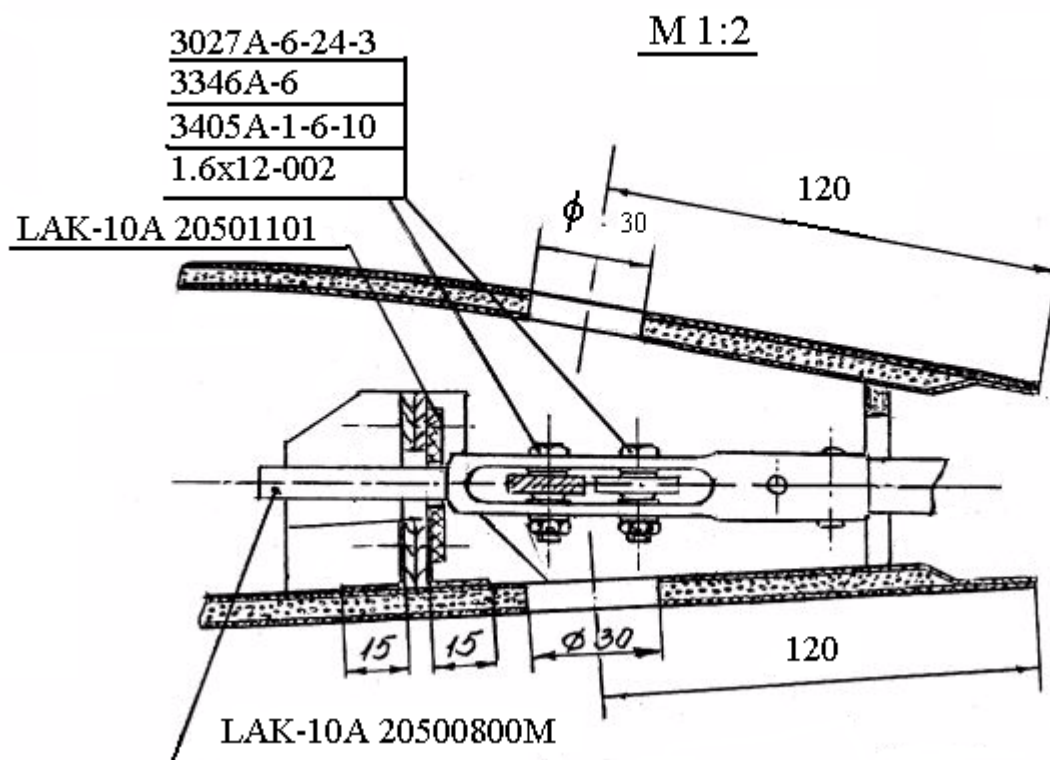
Sketch No.6

- e) inspect the main aileron control unit levers LAK-10A 20 50 08 00 M connection to the push-rods LAK-10A 20 50 07 00 M, LAK-10A 20 50 09 00 M. In the case if corrosion damaged hardware is found, replace them with new bolts 3027A-6-24-3, nuts 3346A-6, washers 3405A1-6-10 and cotter pins 1.6x12-002. To do this make openings of Ø30 mm diameter in the top and bottom skins of the wing (see sketch No.6);

- f) with the help of flash light through the opening l=80 mm in the aft wall of the wing (see sketch No.4) and opening of Ø30 mm diameter in the top and bottom skins of the wing (see sketch No.6) inspect the main aileron control unit LAK-10A 20 50 08 00 M connecting hardware: bolts 3051A-3-20, nuts 3350A-3 and washers 3401A1.5-3-10, which connect the guides LAK12 20 50 11 00 M with the plates LAK-10A 20 50 11 01. In a case if hardware is damaged by corrosion, replace with the new hardware;

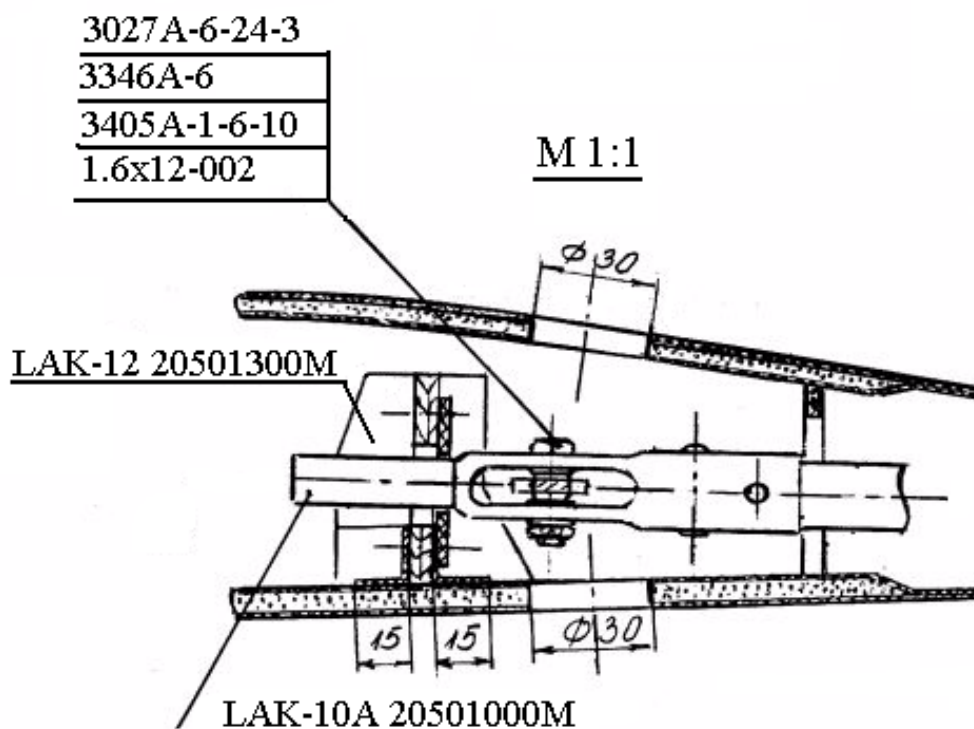
Sketch No.7

- e) inspect the outboard aileron control levers LAK-10A 20 50 10 00 M connection to the push-rod LAK-10A 20 50 09 00 M, if corrosion damaged hardware is found (bolts 3027-6-24-3, nuts 3346A-6, washers 3405A1-6-10 and cotter pins 1.6x12-002), replace them with the new ones through the Ø30 mm diameter openings in the top and bottom skins of the wing (see sketch No.7);

- f) lighting with the flash light through the opening l=80 mm in the aft wall of the wing (see sketch No.5) and through the opening Ø30 mm in the top and bottom skins of the wing (see sketch No.7) inspect the aileron outboard control LAK-10A 20 50 10 00 M hardware: bolts 3051A-3-20, nuts 3350A-3 and washers 3401A1.5-3-10 connecting guides LAK-12 20 50 13 00 M with plates LAK-10A 20 50 00 01. In a case if corrosion damaged hardware is found, they must be replaced with the new one.

Attention: fixing-up the openings Ø30 mm in the top and bottom skins of the wing, refer to the wing internal and external fiberglass layers lay-up schedules given at the Pages 16,17,18.

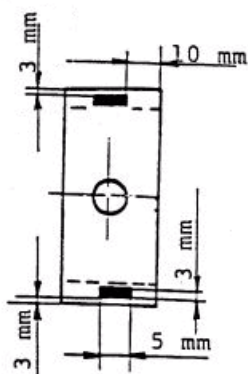
Sketch No. 11

- a) place the wing on the supports (see sketch No.11);
- b) remove the paint from the spar cap at the end of the spar (see view indicated by the arrow N);
- c) connect the plastic tube to the wing water ballast tank and fix it to the support (see sketch No.12);
- d) fill the water ballast tank with the water;
- e) measure the electric resistance between the spar cap and water ballast tank (wire of the tester place into the tube). Allowed electric resistance is $50 \text{ kOhm} < R = \infty$,
- f) after the measurements are finished, paint the spar caps at the points where measuring was done.

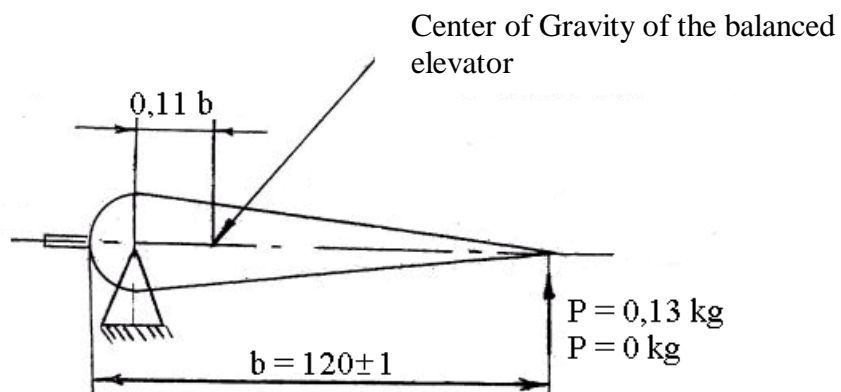
Rudder balancing scheme

22. Check the weight and static moment for the rudder. Checking is done after local repairs or local or complete re-painting of the control surface. Elevator is balanced as it is indicated at a scheme, sketch No.19. Allowed weights and moments for the elevator are given in the table Nr.4.

Parameter to control	Allowed limits
Mass of the rudder, G	5.8 ÷ 6.7 kg
