Information Bulletin No. 019T.7.58.002 I

Inspection of the tow release

control system

1. Subject: Inspection of the tow release control system.

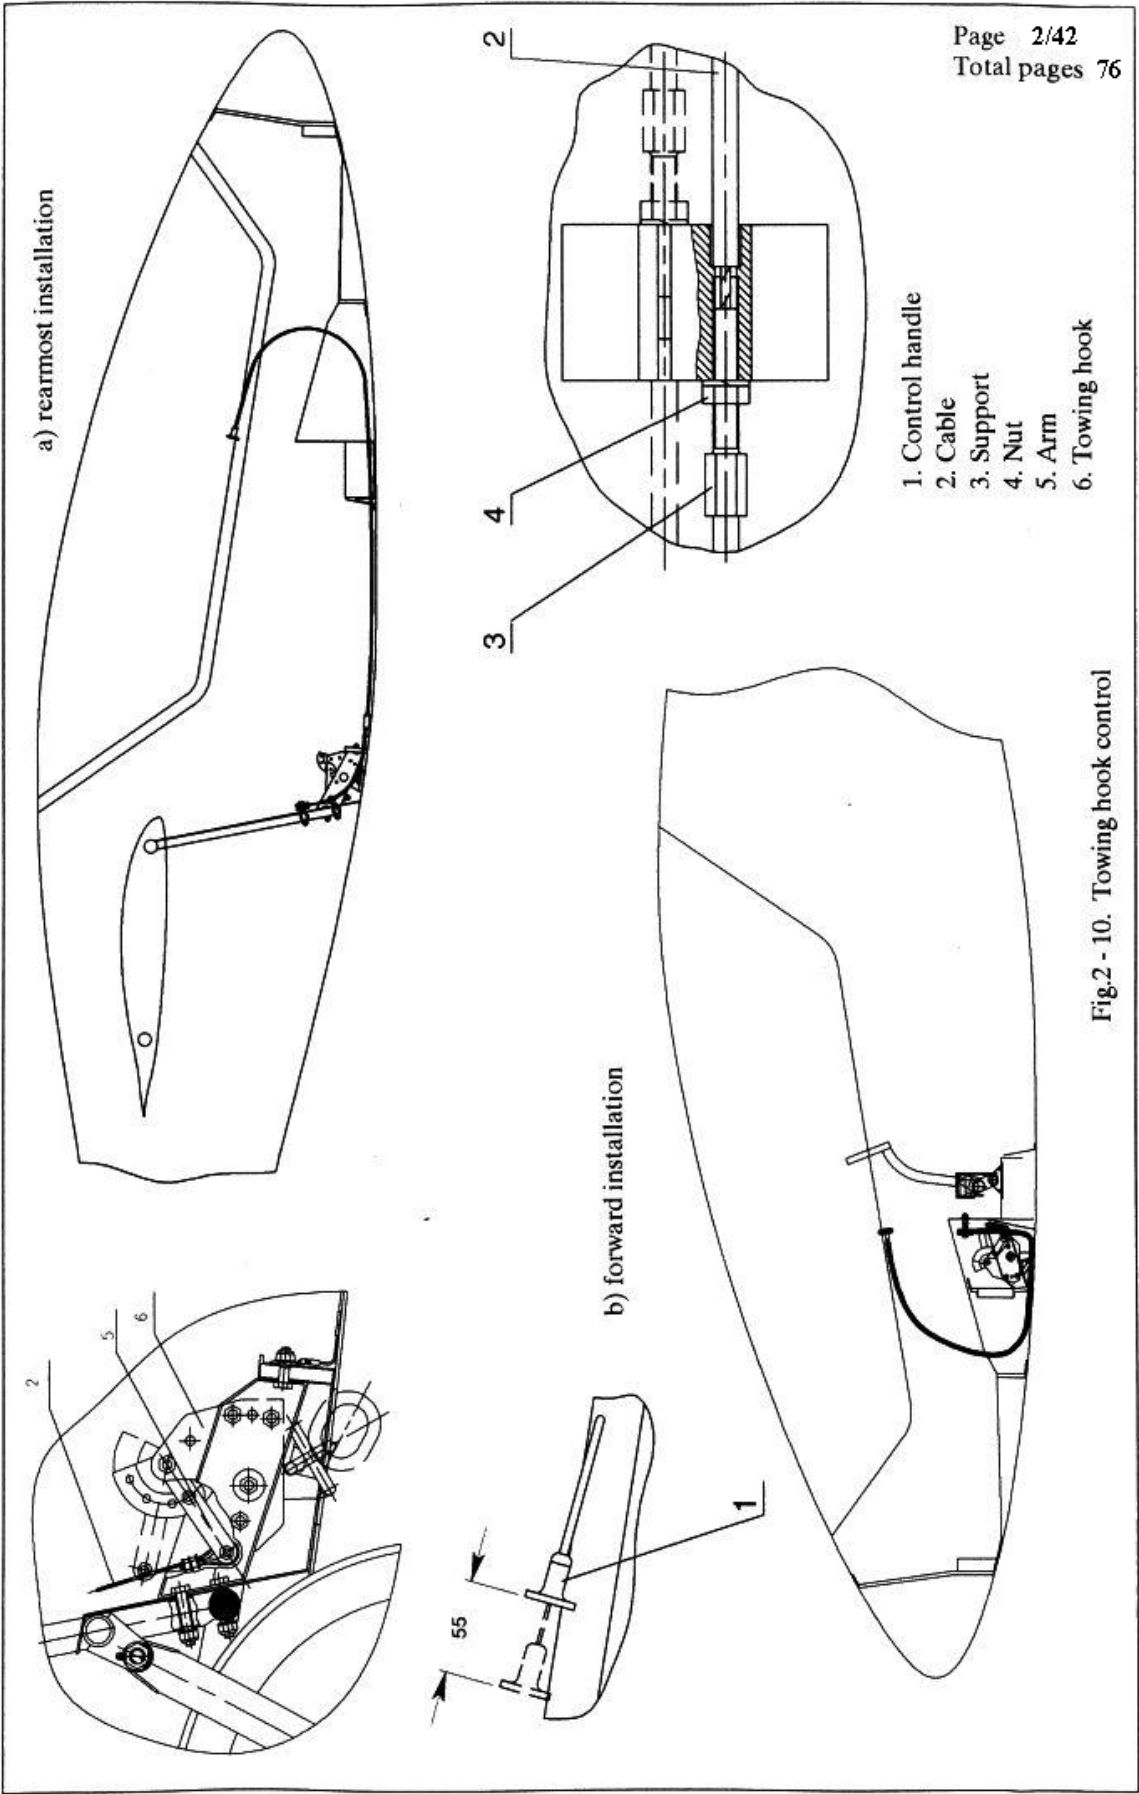
3. Reason: The tow release mechanism was rubbing against the top of the covers on gliders LAK-17AT S/N 182 and S/N 188.

- a) Made a hole according photo No 1.
- b) After cutting hole it is necessary to mount cover and inspect tow release control system (see photo No 2, 3) according fig. 2-10 towing hook control.

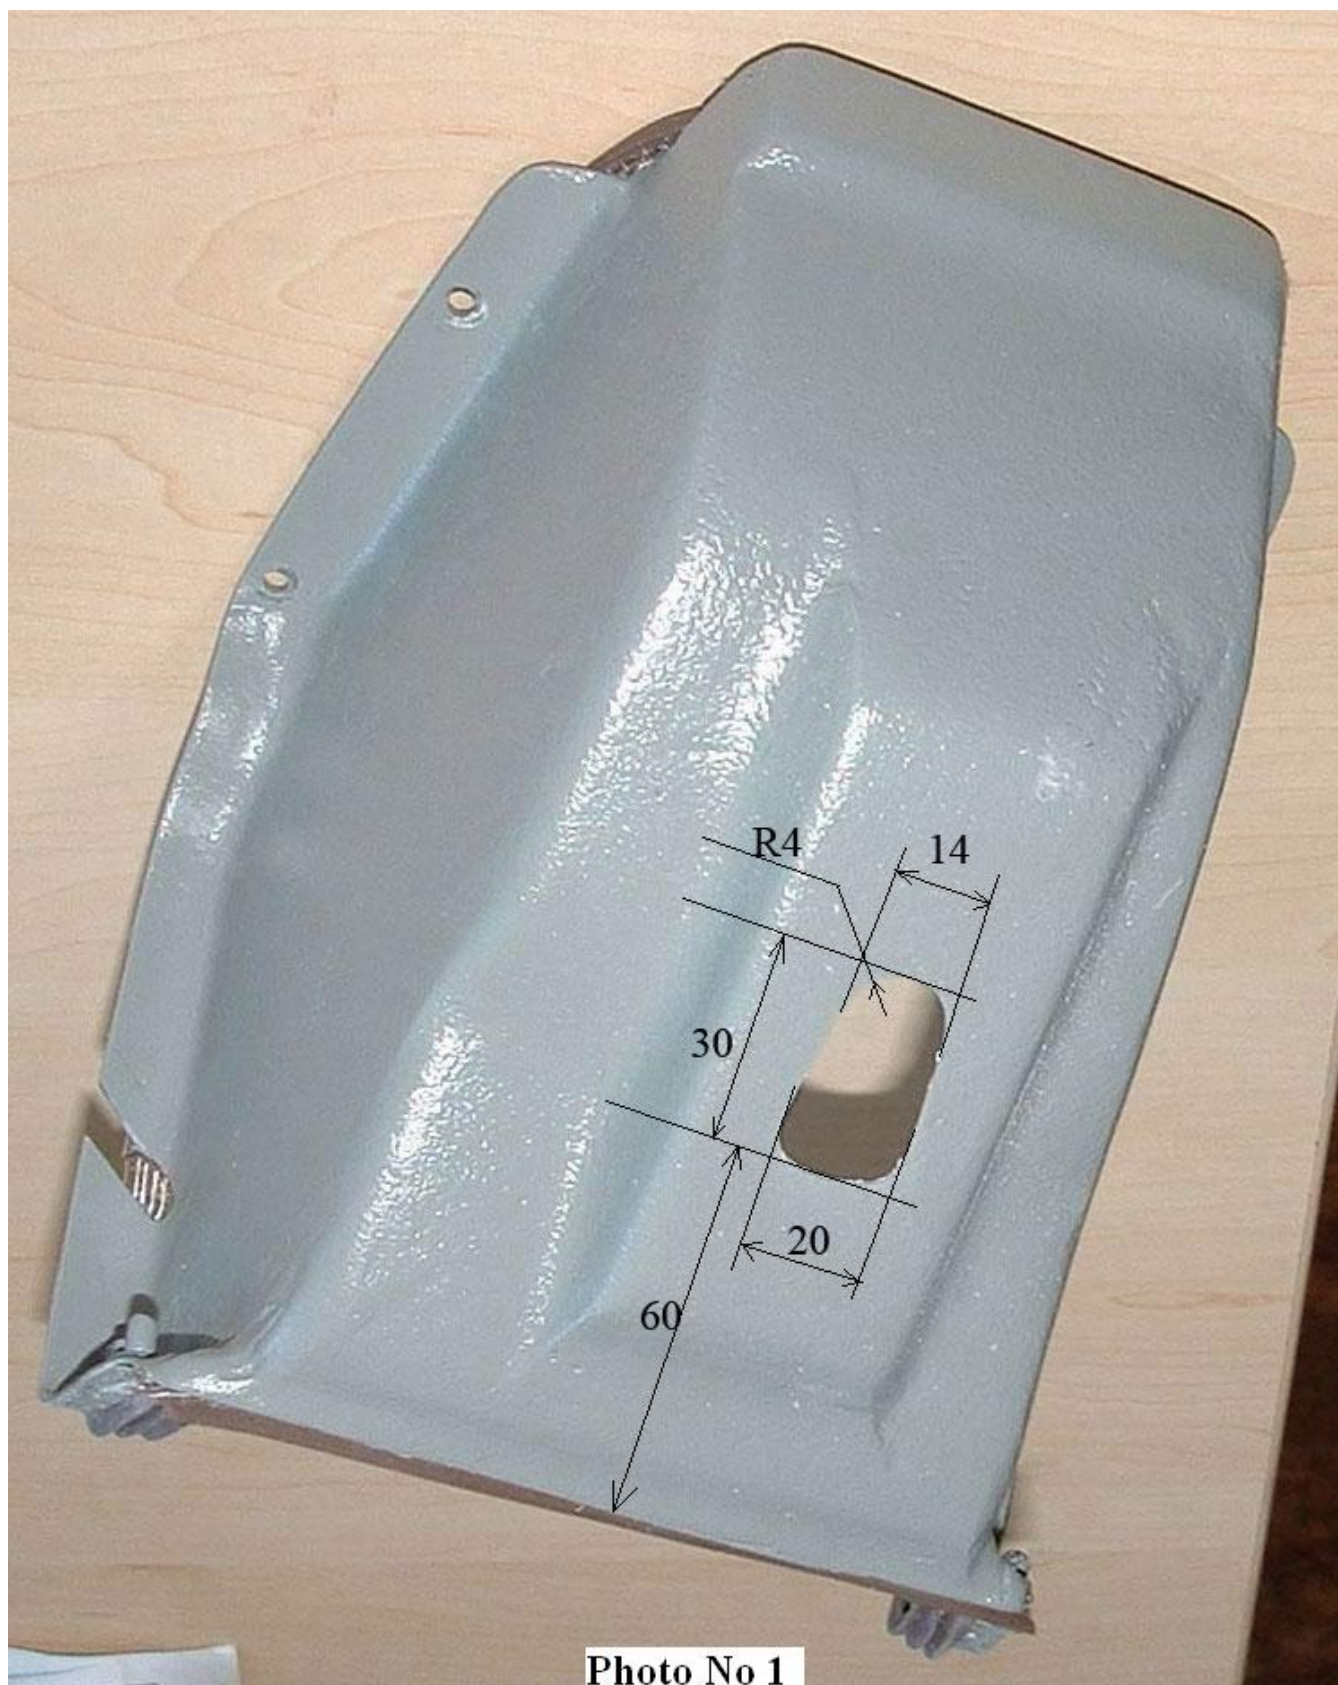
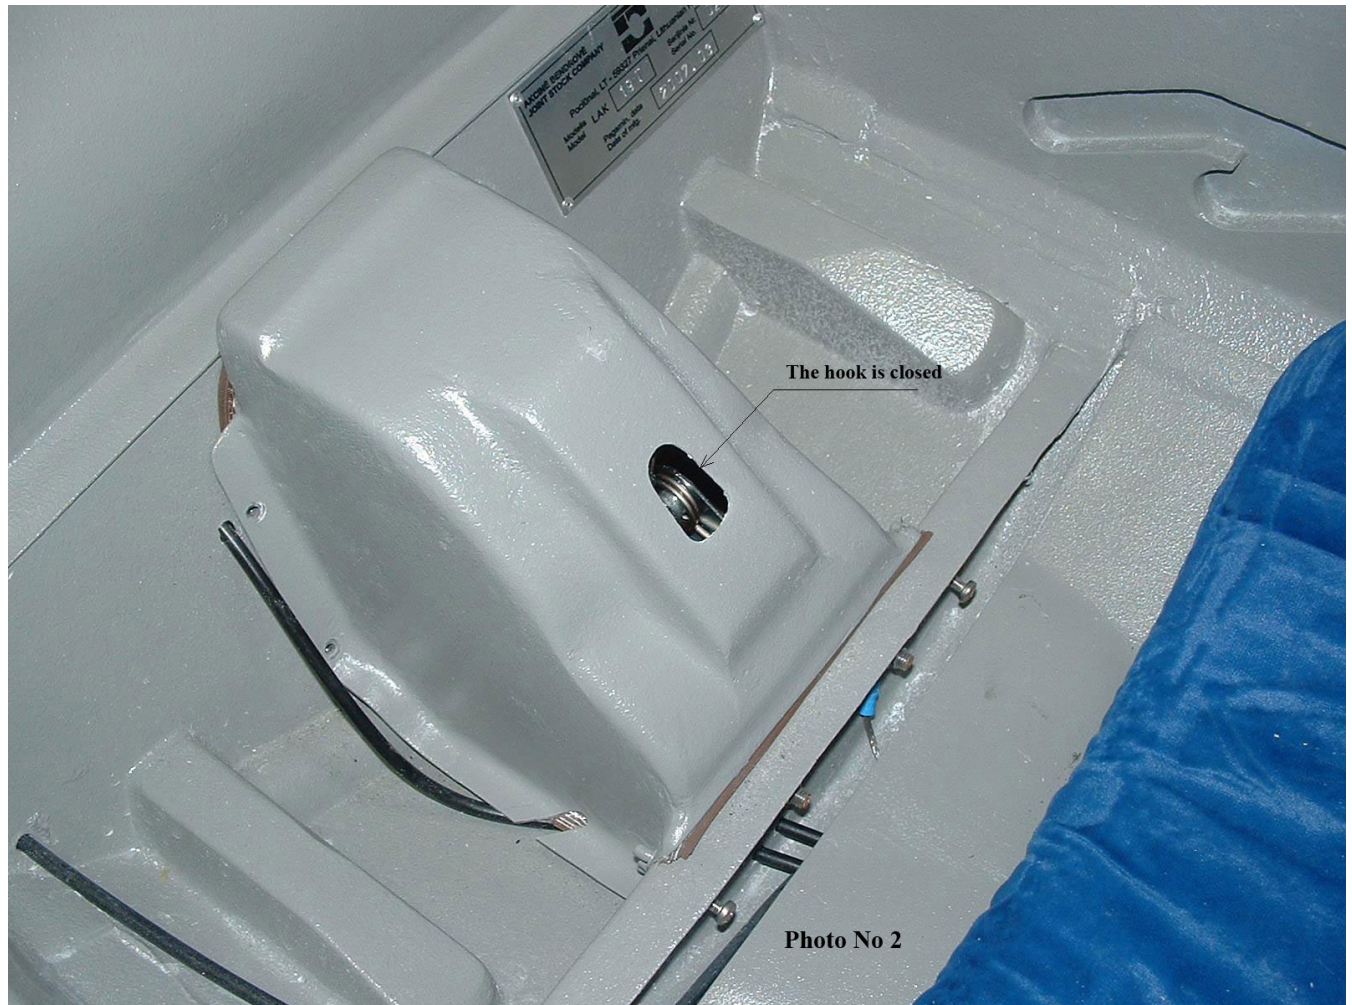
If motion of the handle is less 55 mm you must removed the cover from towing hook, arranged in central part of fuselage at the main frame and chech motion of the tow release handle. If motion of the handle is 55 mm it signify – the release mechanism was rubbing against the top of cover. For correction it is necessary:
