Service Bulletin No. 019T.8.Re.007A

Extension of the approved lifetime from 1000 flight hours to 3000 hrs for the self-sustaining powered sailplane LAK-19T

Extension of the approved life time from 1000 flight hours to 3000 hrs.

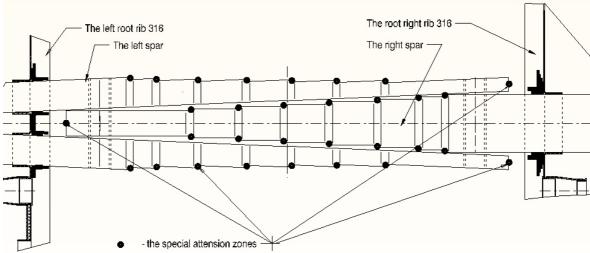
Fig.1. The wing spar.

14. To check surfaces of ends of wing spars (Fig.1), surfaces of external wing root ribs, paying special attention to connection zones of root ribs to spar ends and wing shells. If there are some splits or other damage on glass fiber reinforced plastics it is necessary to repair the damaged place.

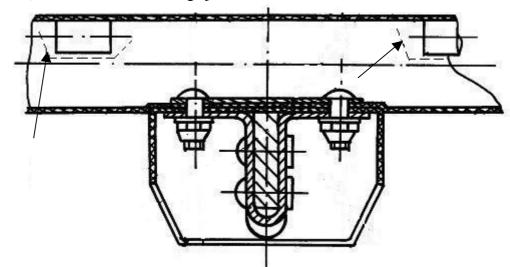
- 15. To check external surfaces of wings, ailerons, flaps, fuselage, stabilizer, elevators and rudder. The special attention zones:
 - a) the surfaces around hinge joints of control unit of elevators on the horizontal tail.

In zones where paint has cracks it is necessary to clean off the paint and check glass fiber reinforced plastic for cracks and if necessary to repair the damage.

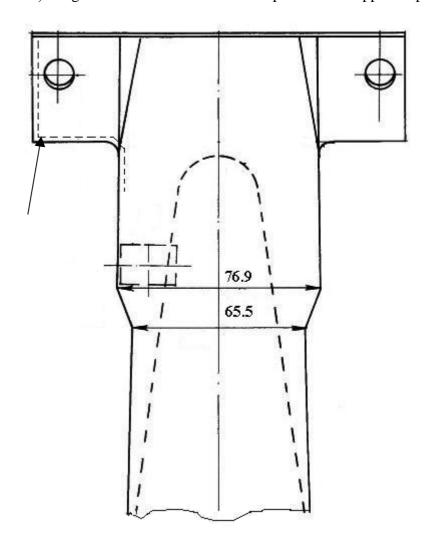
b) the glued zones of the vertical tail spar onto the upper fin part

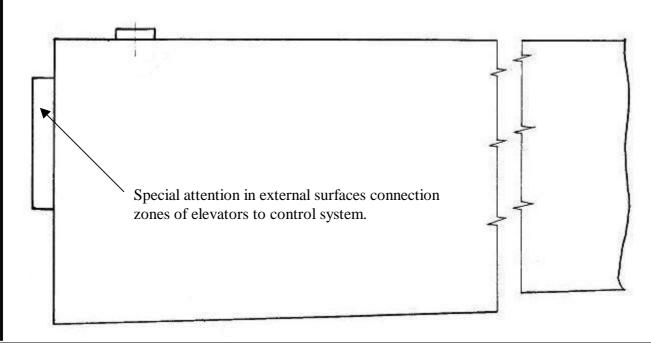
c) the elevator root rib

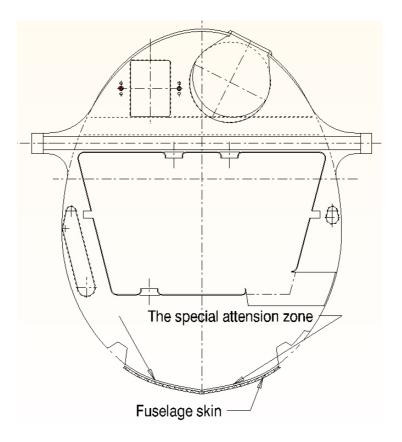
d) the fuselage bulkhead
