**Information Bulletin No. 019.7.58.005 I**

**Inspection of the tow release**

**control system**

**Type:** LAK-19

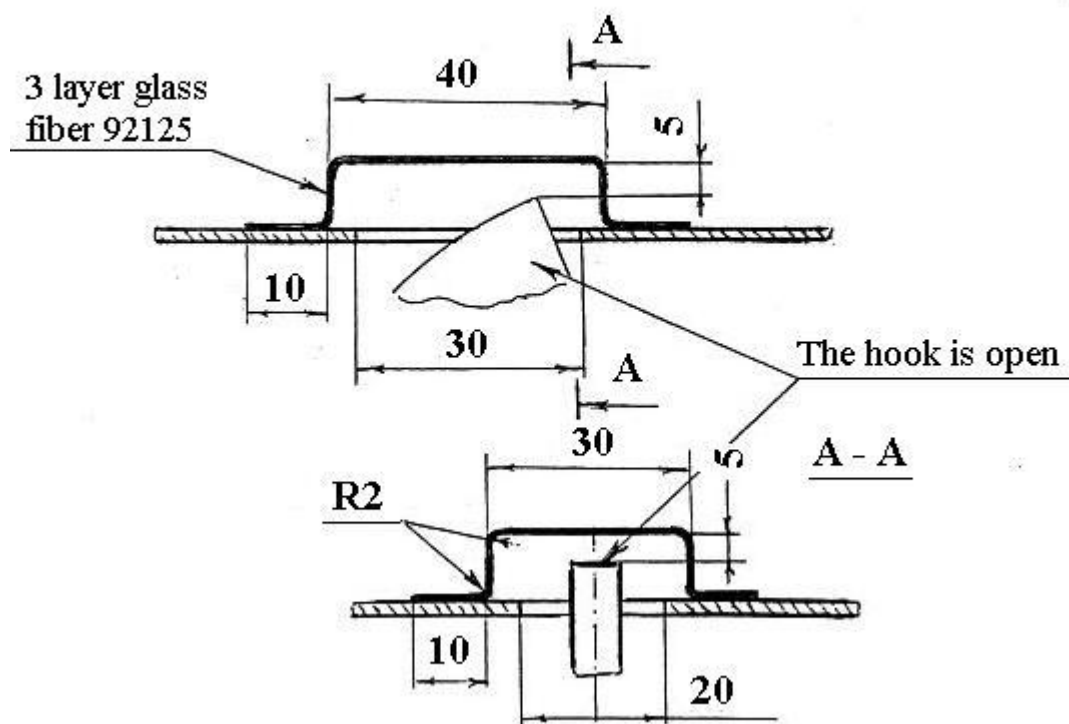
**3. Reason:** The tow release mechanism was rubbing against the top of the covers on gliders LAK-17AT S/N 182 and S/N 188.

If motion of the handle is less 55 mm you must removed the cover from towing hook, arranged in central part of fuselage at the main frame and chech motion of the tow release handle. If motion of the handle is 55 mm it signify – the release mechanism was rubbing against the top of cover. For correction it is necessary:

After inspection you must hole close with glueing 3 layer glass fiber 92125 cover according Sketch No 1 or place an order for new cover.
