Page 1 of 2	Technical Note LAK-17B / LAK-17BT / LAK-17B FES TN No. 2	JSC "Sportin aviacija ir Ko" Poci nai, LT-59327, Prienai, Lithuania
----------------	---	---

Subject: Inspection of the console (outer wing) spar holder finger looseness

Applicability: LAK-17B / LAK-17BT / LAK-17B FES EASA-Type certificate: is not certified
SN 201 ÷ SN 208

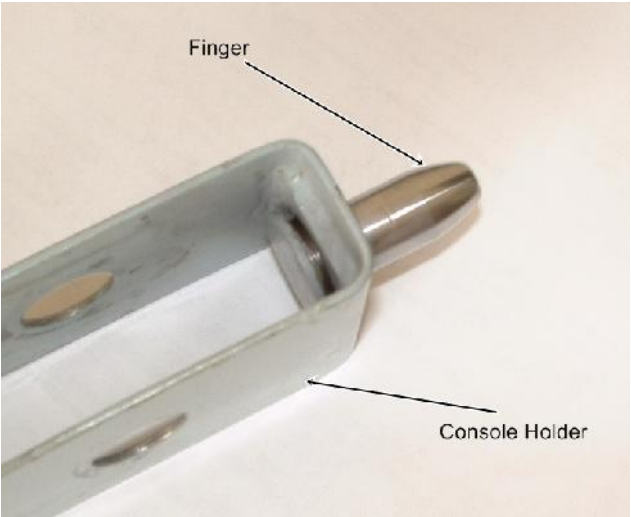
Fig. 1

Reason: Incorrect tolerance of interference fit between the finger and console holder.

1. Grab the finger on the end of the spar of the console (outer wing) (Fig. 1) with one hand and try to pull it up (Fig.2) and pull it down (Fig.3) while holding the whole console constrained so that it does not move.
2. If you manage to pull the finger upwards or downwards and see that the finger is loose it needs to be tightened.
