N54°39.3' E024°03.5'	<h2>Technical note</h2>	Doc. No. 017.25.001
		Revision 0
		Date: 2025-10-30
"SA ir Ko" EASA.AP160	<b>Replacement of the shunt screws</b>	Page 1 of 3

**Subject:** FES system: improved screw connection of the connection cables to the shunt.

**Applicability:** LAK-17B FES – all serial numbers;  
LAK-17B FES mini – all serial numbers from sn 046 (inclusive);  
LAK-17C FES – all serial numbers from sn 309 (inclusive);

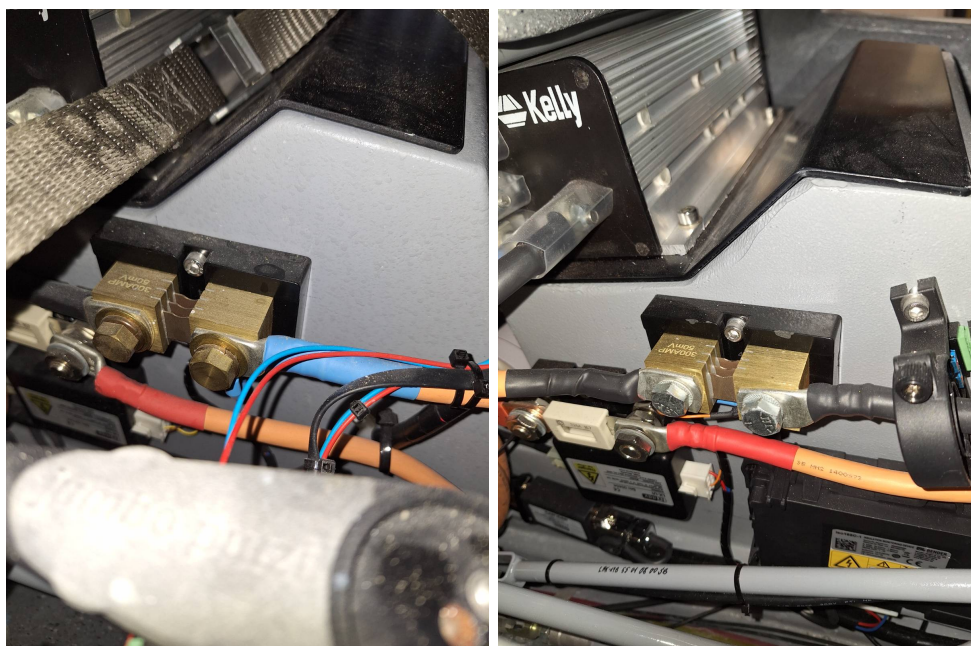
**Figure 1**

**Reason:** A shunt (small resistor) is installed in the cable between the negative pole of the battery and the controller to measure the current from the FES batteries. The screw connections of the large connection cables on the shunt were originally made with brass screws. These brass screws have torn off in several cases, possibly due to excessive tightening torque. To make this screw connection more robust and reliable, the brass screws are replaced by steel screws.

Whether the screw connection is made with steel screws (galvanised, light silver colour) or brass screws (bright brass) can be seen through the main spar window. (fig. 1a, fig 1b).

(a) Shunt with brass screws

(b) Shunt with steel screws

1. Verify the type of screws. The shunt is located on the left wall of landing gear box.  
If the screw connection is already fitted with steel screws, no change is to be made.
2. If the screw connection is made with brass screws, these must be replaced with steel screws in accordance with the accomplishment instructions provided in this document.

The brass screws previously used to fasten the high-current cables to the shunt must be replaced with steel screws.

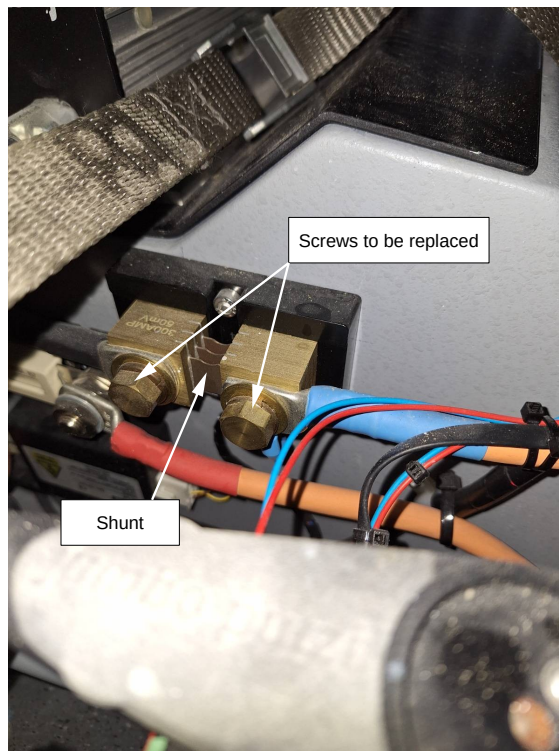
(a)

The shunt is located under the plastic cover, on the left wall of landing gear box (Fig. 2a).

The connection cable of the batteries must be disconnected during maintenance work.

After removing the plastic cover, the brass screws including the brass washers on the shunt connections can be removed. When installing the new steel screws with the new lock washers, ensure the correct orientation of the lock washer (Fig. 2b). The steel screws are additionally secured in the threaded area with medium-strength screw locking adhesive (Loctite 243 or similar). The tightening torque is 17 Nm. The plastic cover must then be refitted.
