| N54°39.3' E024°03.5' | <h1>Technical Note</h1> | Doc. No. 017.25.001 |
| "SA ir Ko" EASA.AP160 | Replacement of the shunt screws | Page 1 of 3 |

Subject: FES system: improved screw connection of the connection cables to the shunt.

Applicability: LAK-17B FES – all serial numbers;
LAK-17B FES mini – all serial numbers up to sn 046 (inclusive);
LAK-17C FES – all serial numbers up to sn 309 (inclusive);

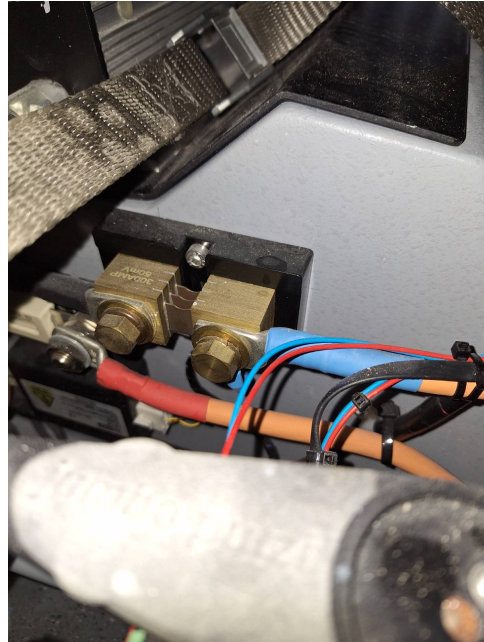
Reason: A shunt (small resistor) is installed in the cable between the negative pole of the battery and the controller to measure the current from the FES batteries. The screw connections of the large connection cables on the shunt were originally made with brass screws. These brass screws have torn off in several cases, possibly due to excessive tightening torque. To make this screw connection more robust and reliable, the brass screws are replaced by steel screws.

Whether the screw connection is made with steel screws (galvanised, light silver colour) or brass screws (bright brass) can be seen through the main spar window. (fig. 1a, fig 1b).

(a) Shunt with brass screws

1. Verify the type of screws. The shunt is located on the left wall of landing gear box.
If the screw connection is already fitted with steel screws, no change is to be made.
2. If the screw connection is made with brass screws, these must be replaced with steel screws in accordance with the accomplishment instructions provided in this document.

The brass screws previously used to fasten the high-current cables to the shunt must be replaced with steel screws.

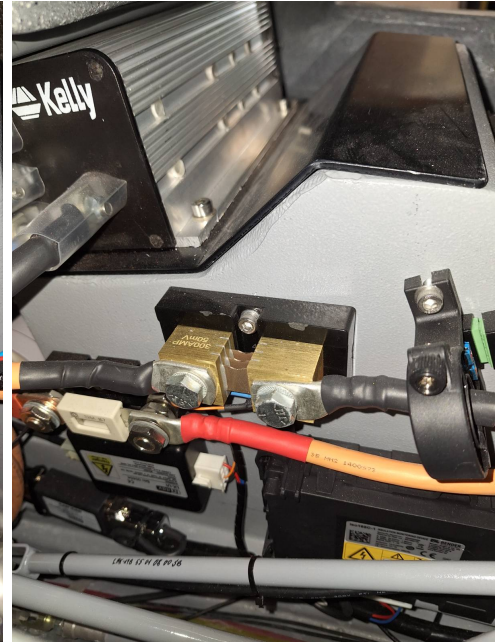
(b) Shunt with steel screws
