JSC "SPORTINĖ AVIACIJA"	Page 1
Service Bulletin No. 012.5. Re.002A	Pages 33

Service Bulletin No. 012.5.Re.002A

**SERVICE WORKS FOR THE GLIDER LAK-12
AFTER 15 YEARS OF OPERATION**

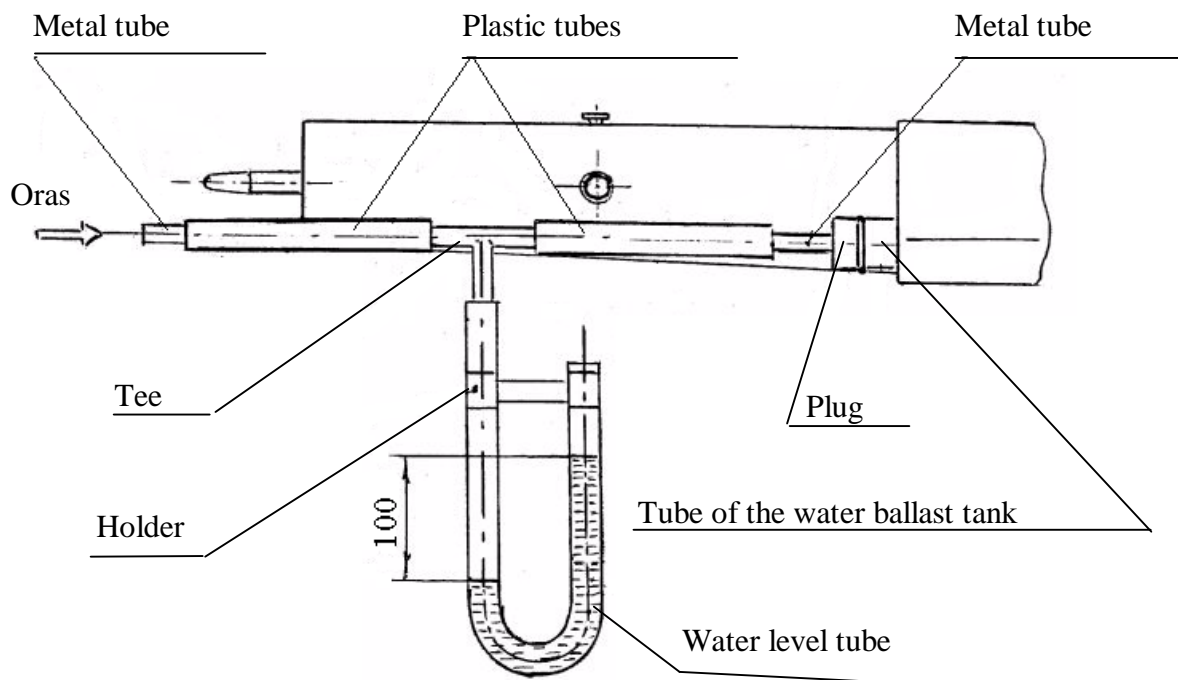
Sketch No. 12

General scheme of the water ballast tank leakage test equipment

Remark: according to the typical technology LAK-12 2000000102.02. 12020.09 for repairs of the LAK-12 wings, water ballast tanks are checked for leakage with the altimeter LUN 1121-01 at the air pressure 0.05 ± 0.02 kg/cm² keeping it for 1 hour.
